SD77-SH-0001  
VOLUME 2

SHUTTLE ORBITER OV-102 CDR  
SAFETY ANALYSIS REPORT  
VOLUME II  
STRUCTURES SYSTEMS

27 APRIL 1977

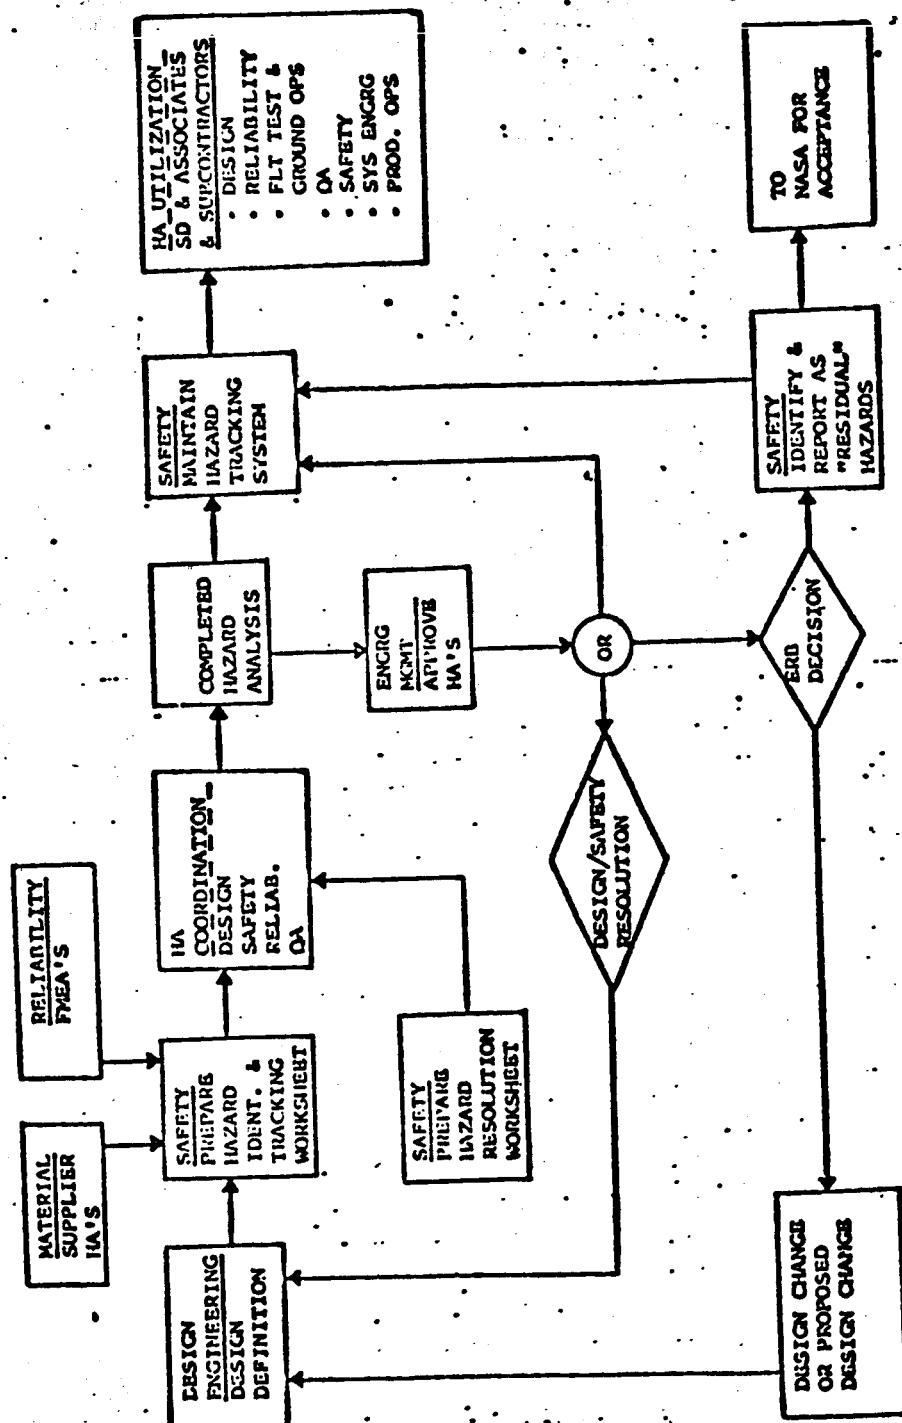
FIGURE 1 - HAZARD ANALYSIS PROCESS

The Hazard Analysis was performed per Rockwell International-Space Division, Reliability and Safety Desk Instruction 400-1. The hazard analysis process, shown in Figure 1, involves the evaluation of the Orbiter in its mission phases by subsystem identified by the System Definition Manual number for hazards in the major hazard groups described in the desk instruction and coded as listed below:
